Condition Assessment Report Sanitary Sewer Systems

Prepared for Burbank Sanitary District

Date: July 14, 2014

Burbank Sanitary District

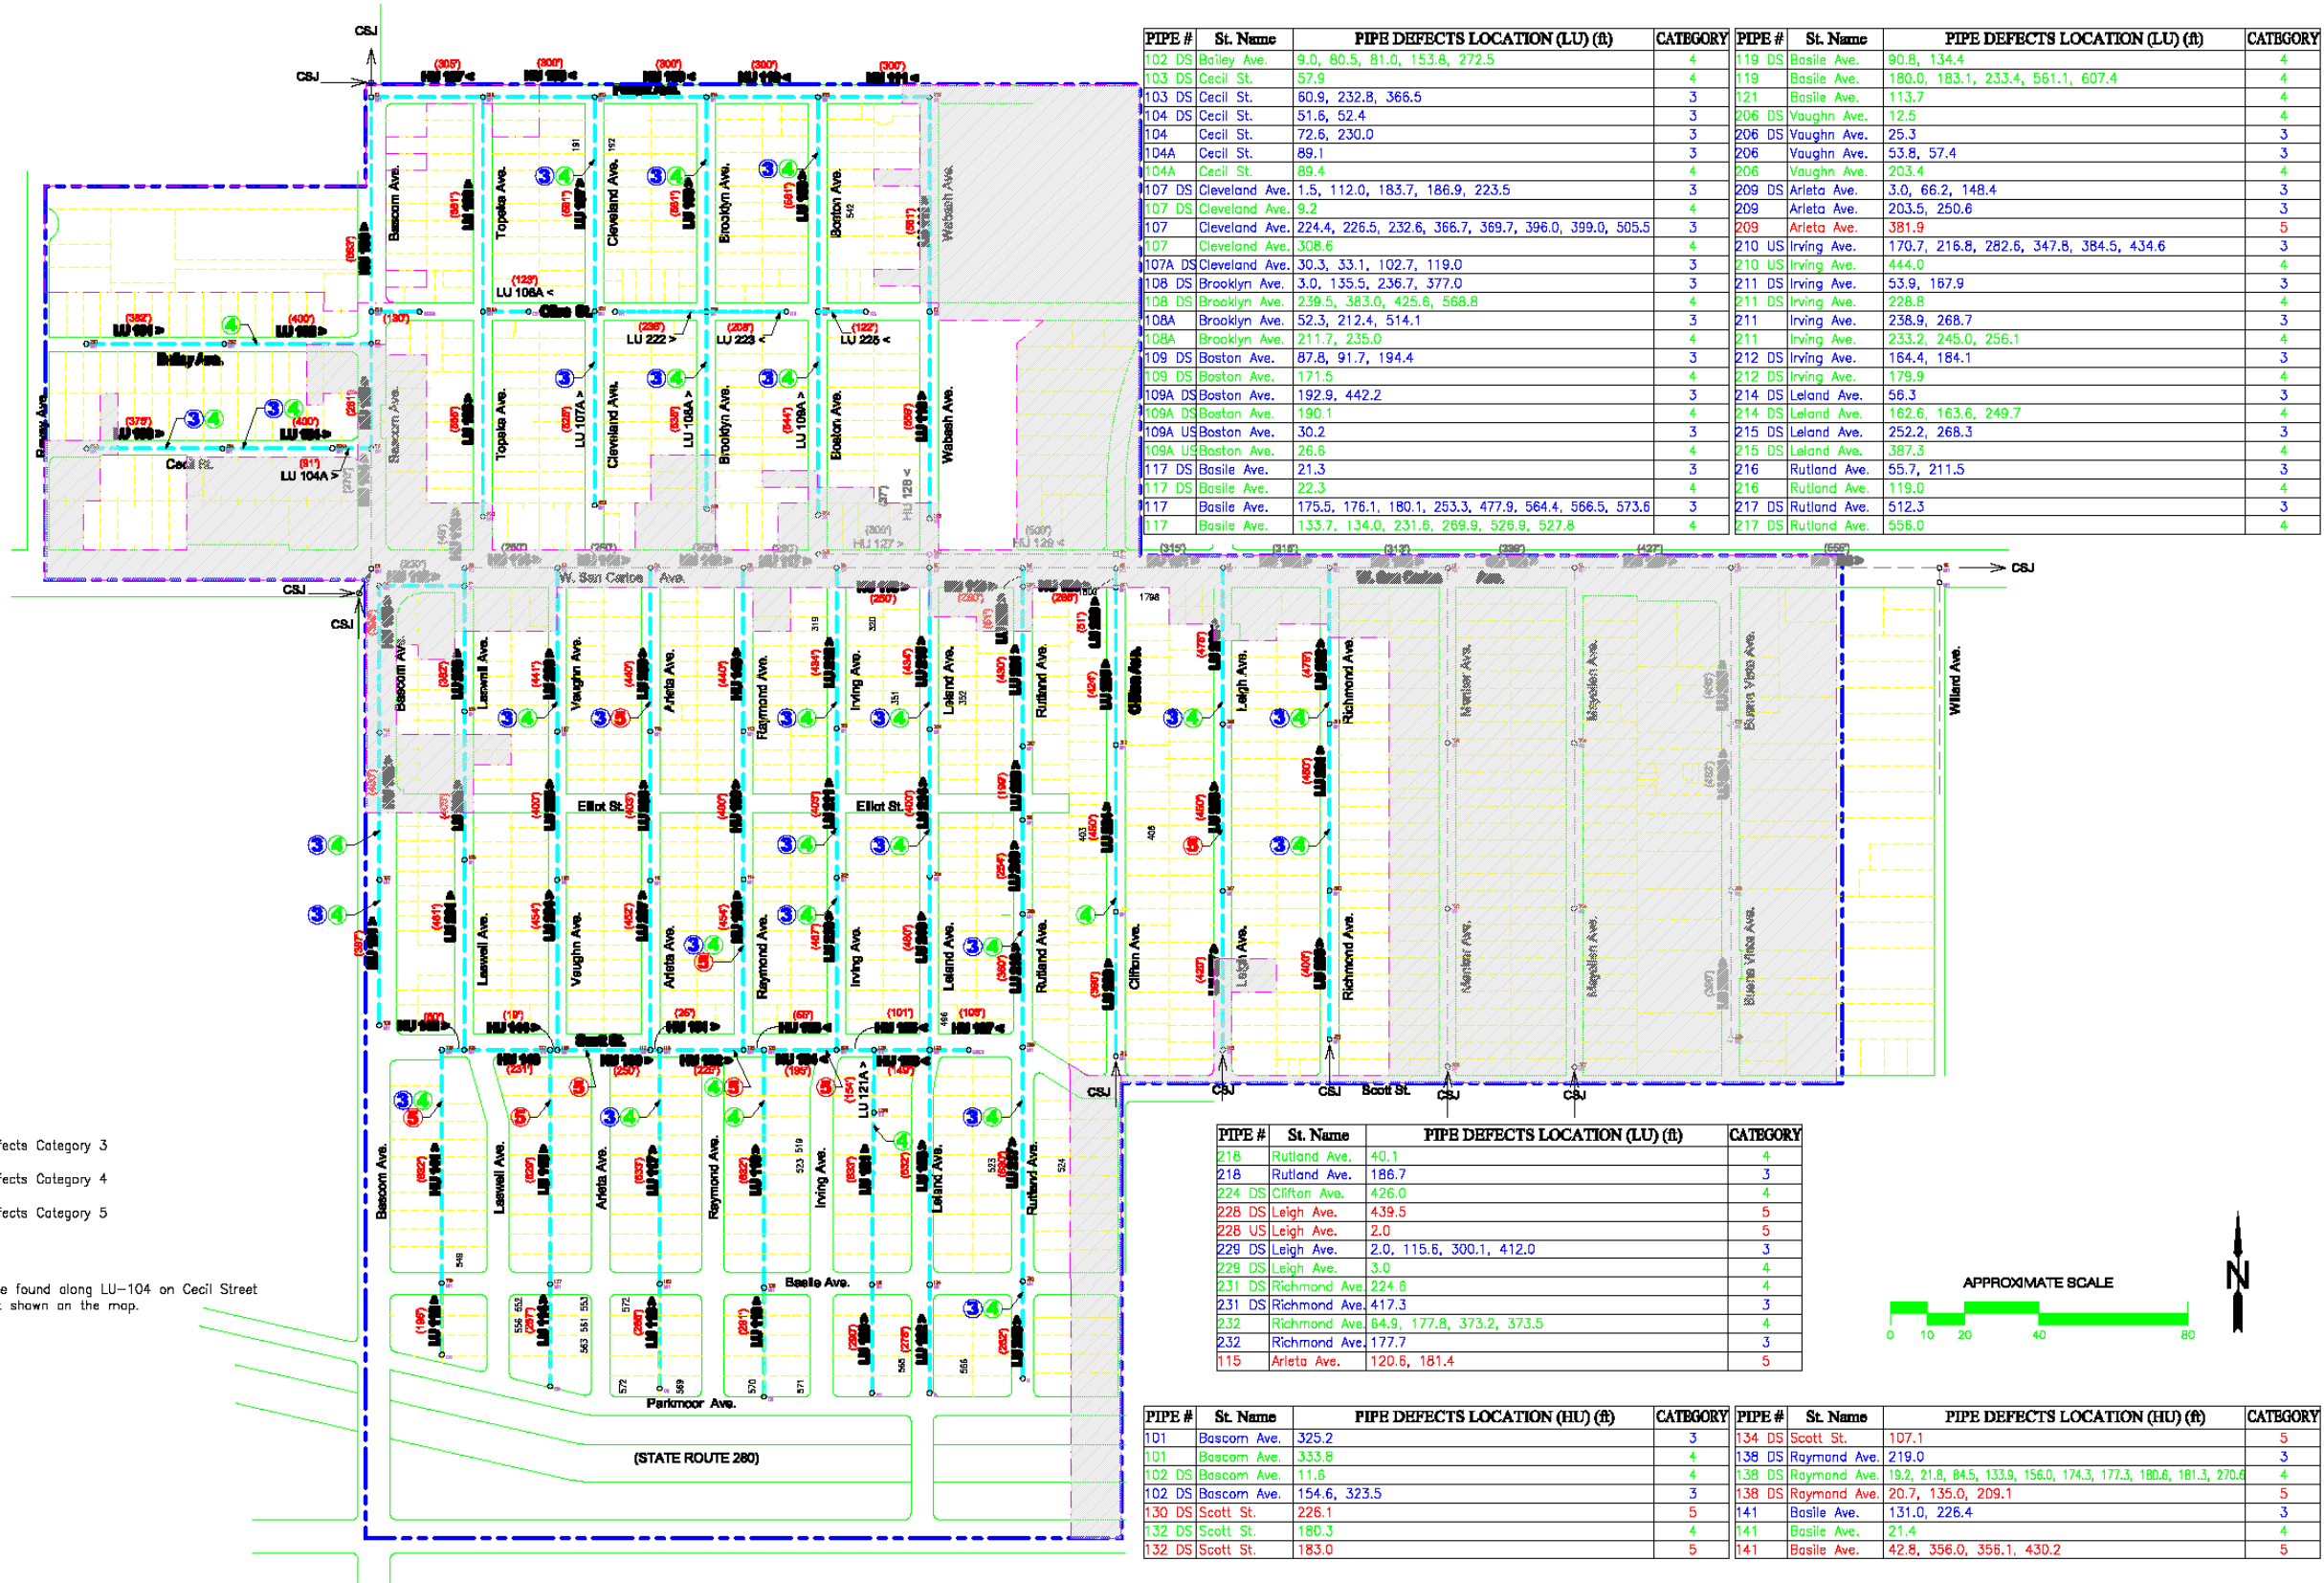
Figure 1-1: Burbank Sanitary District Defects Map

Existing manhole found along LU-104 on Cecil Street at 303.0 ft not shown on the map.

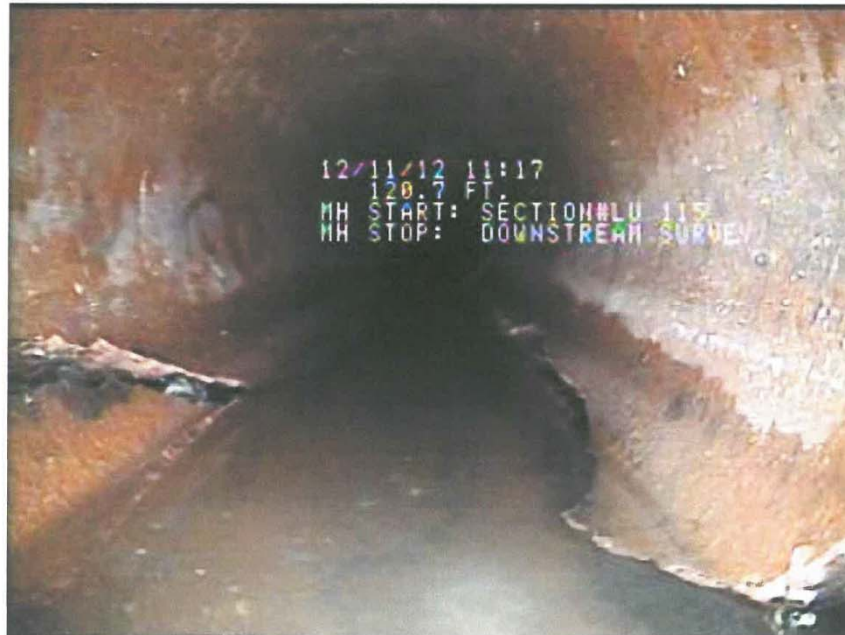
Distance	Length	Code	Reversed	Clock Pos.	Severity	Comment
120.6		BSV	No	8 / 4

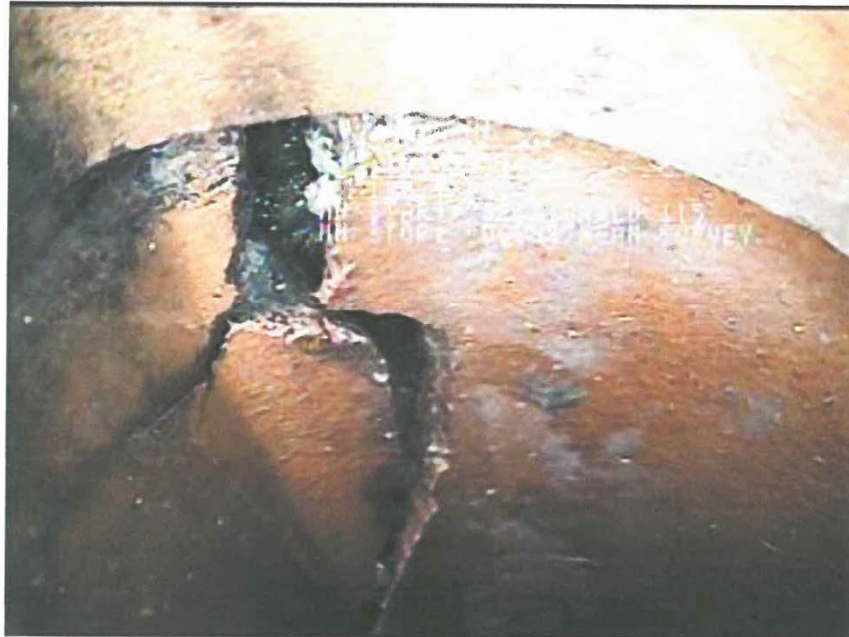
Distance	Length	Code	Reversed	Clock Pos.	Severity	Comment
120.6		BSV	No	8 / 4

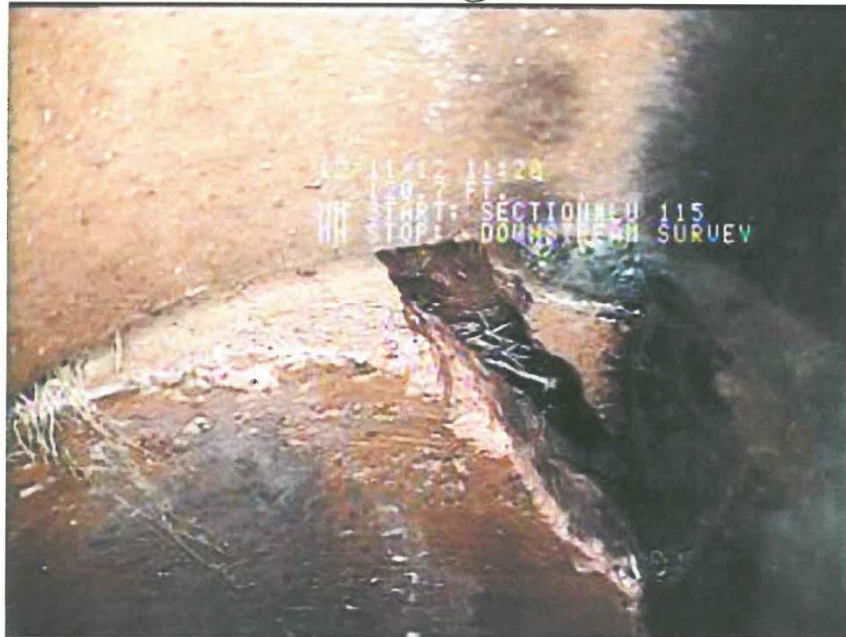
Distance	Length	Code	Reversed	Clock Pos.	Severity	Comment
120.6		BSV	No	8 / 4

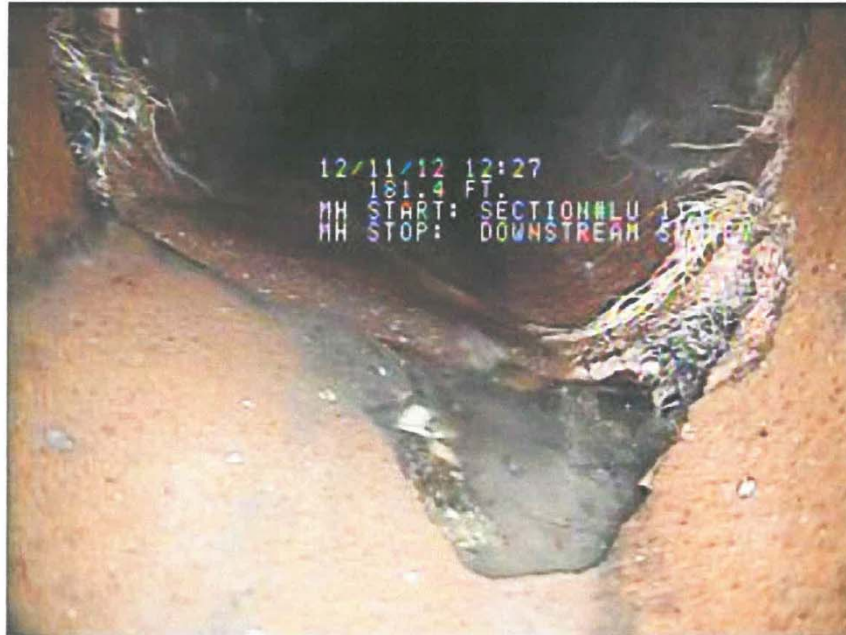
Distance	Length	Code	Reversed	Clock Pos.	Severity	Comment
181.4		BSV	No	5 /
