Condition Assessment Report Sanitary Sewer Systems

Prepared for Burbank Sanitary District

Date: July 14, 2014

Burbank Sanitary District

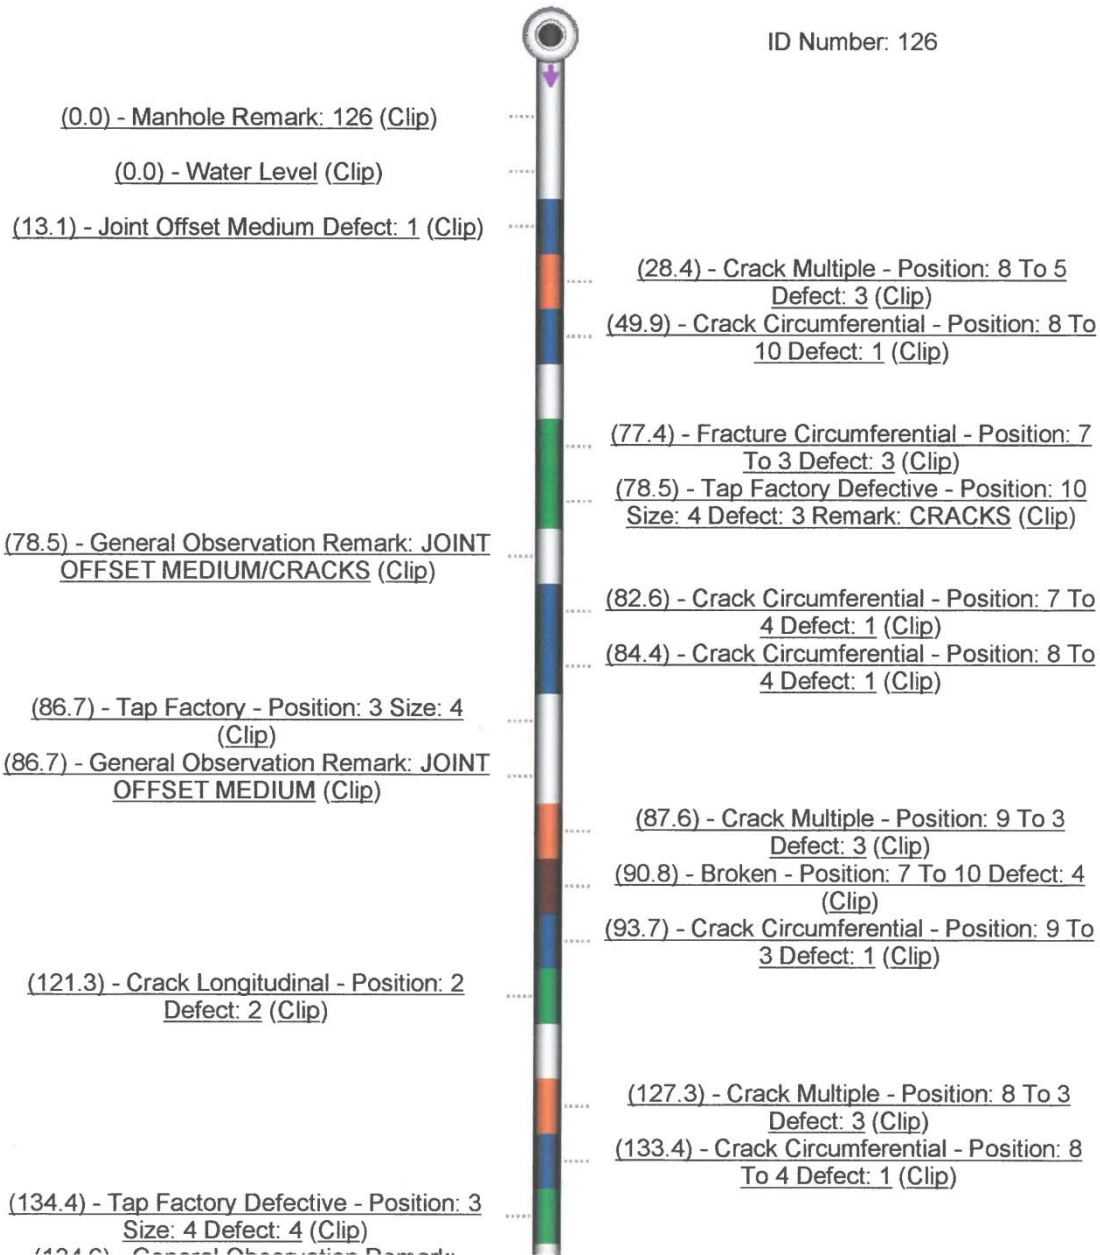
(136.3) - General Observation Remark: <u>JOINT OFFSET MEDIUM (Clip)</u>	(136.3) - Tap Factory Active - Position: 9 Size: 4 (Clip)
	(137.4) - Roots Fine Joint - Position: 8 To 3 (Clip)

(149.5) - Crack Circumferential - Position: 9 To 2 Defect: 1 (Clip)
	(155.8) - Crack Circumferential - Position: 8 To 3 Defect: 1 (Clip)
	(155.8) - Roots Fine Joint - Position: 8 To 4 (Clip)
