BURBANK SANITARY DISTRICT PROPERTY LINE CLEANOUTS

Burbank Sanitary District - Stoppage Call Log 2012 - 2014

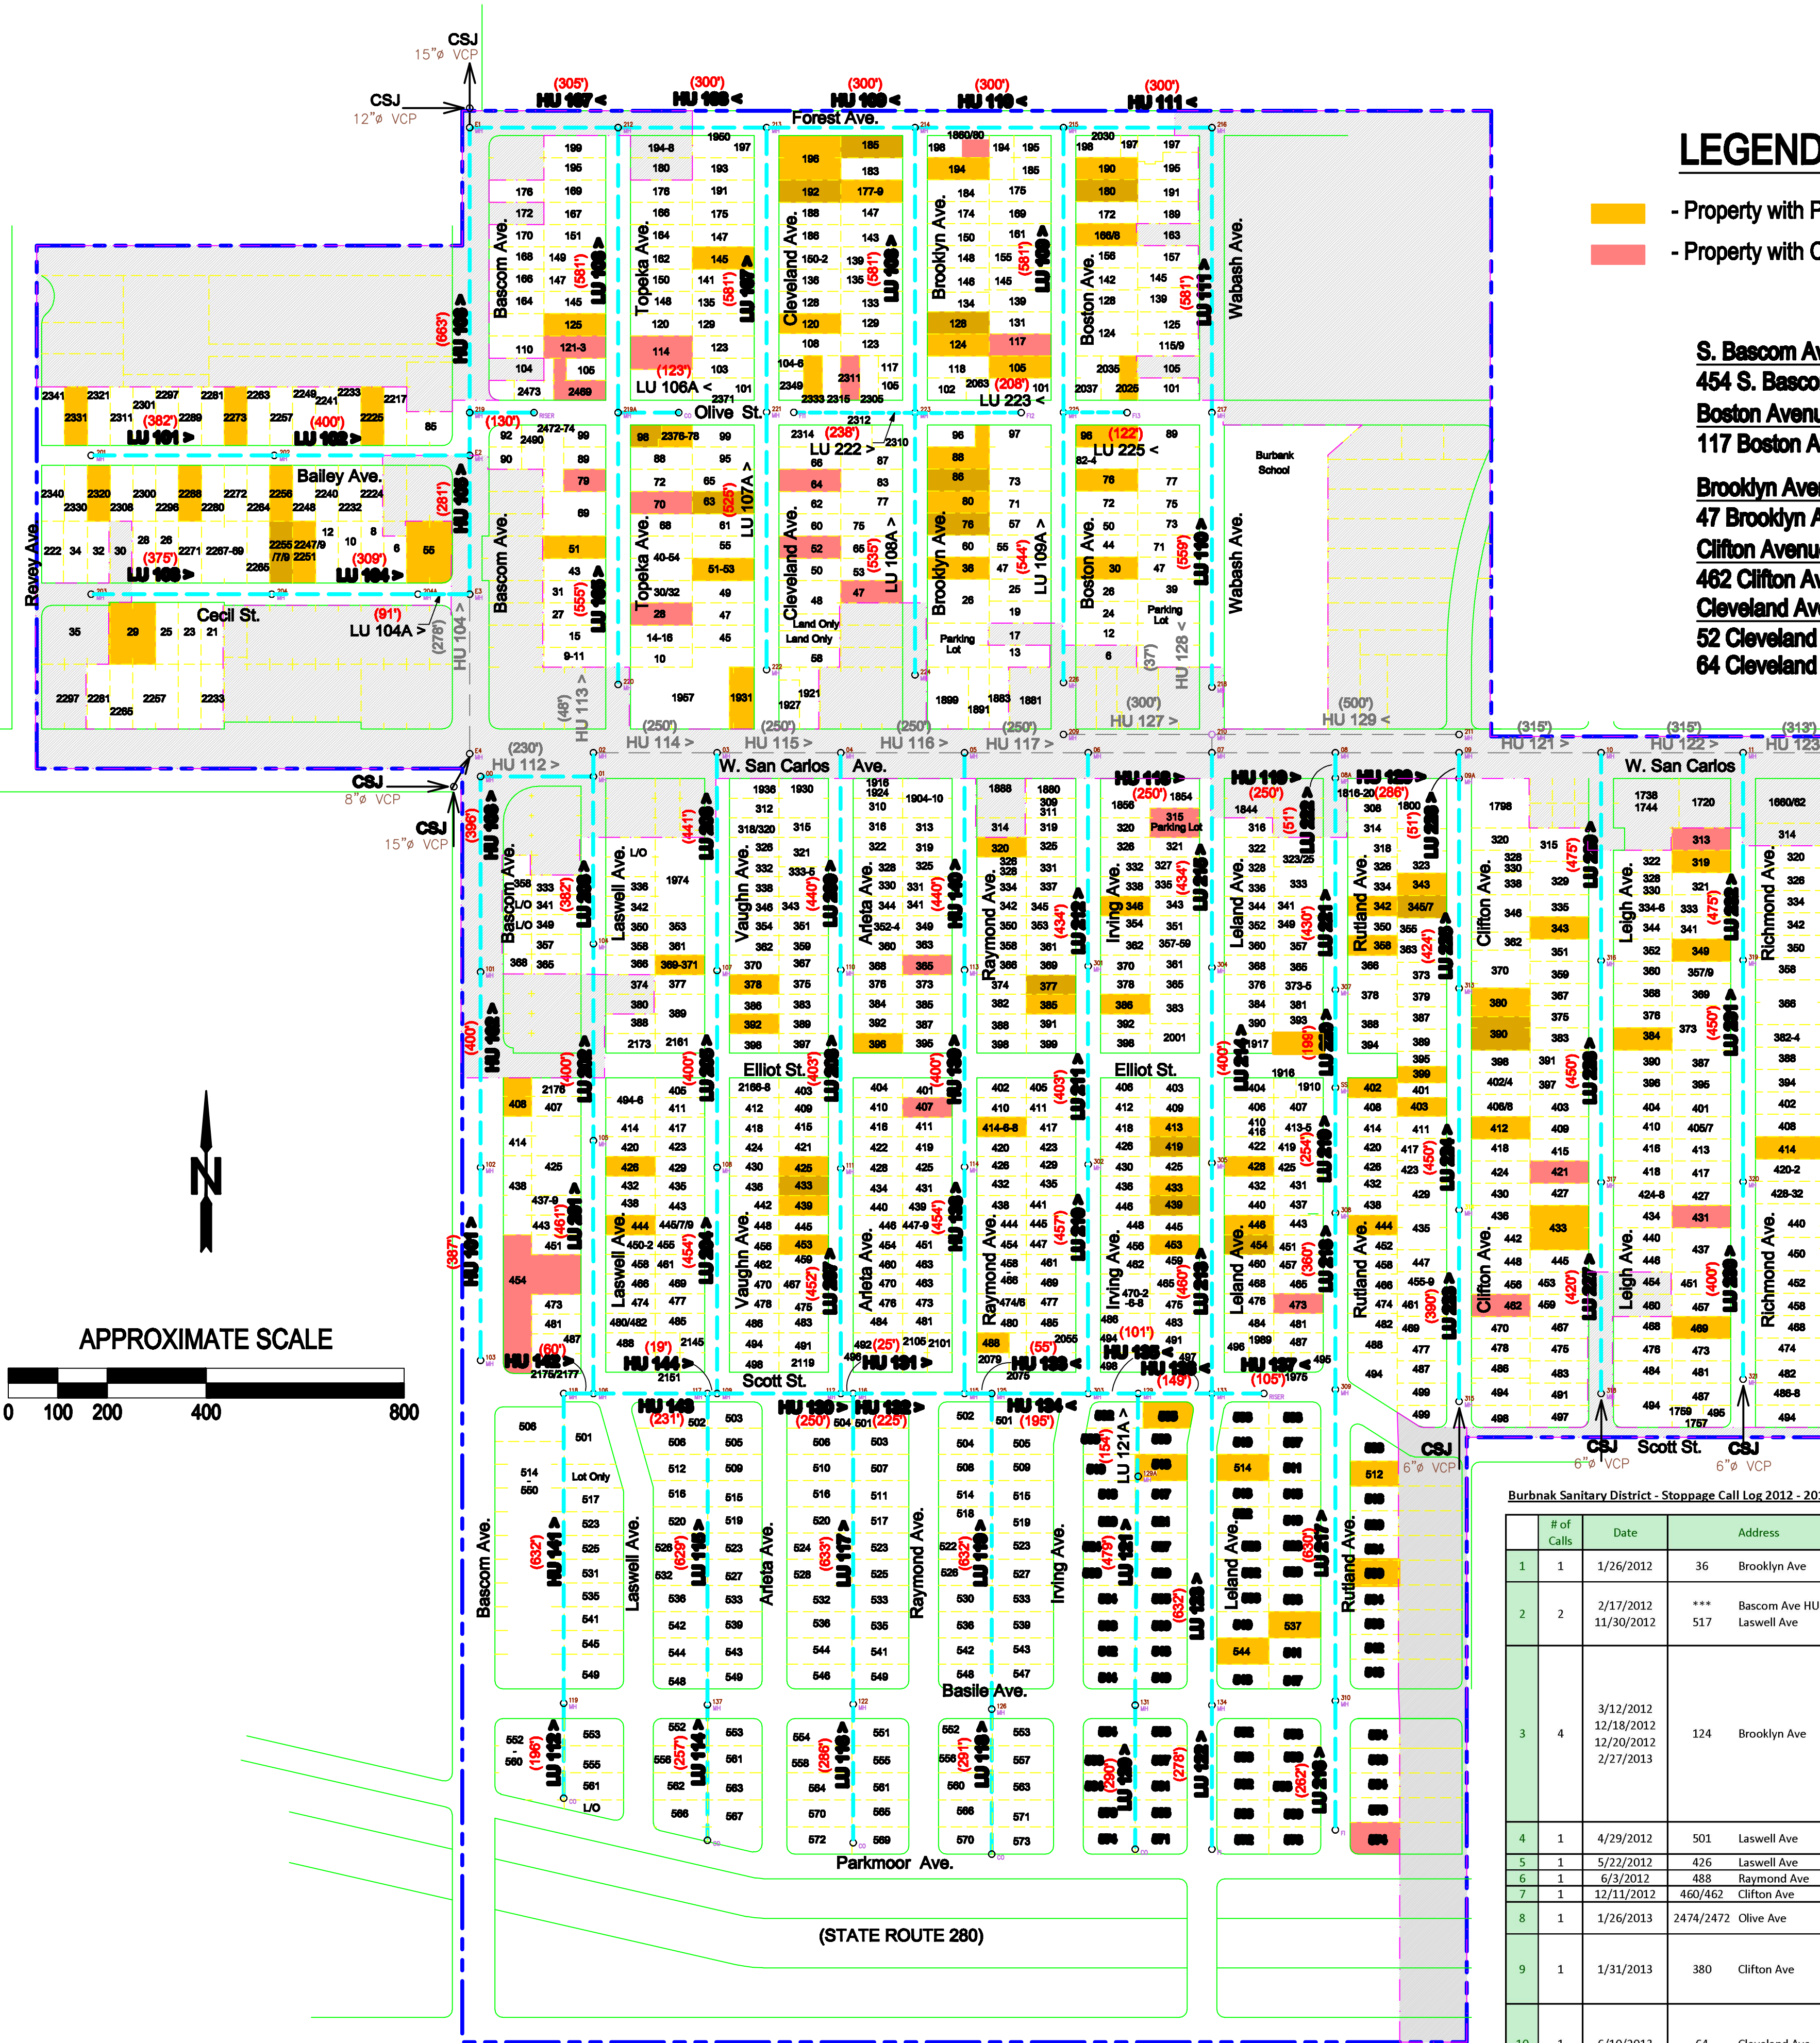
- Property with PL Cleanout
- Property with Cleanout not to Standard (see notes)

454 S. Bascom Ave.: 4 cleanouts on Bascom side of property. 2 caved-in lids and 2 "Water" lids.

117 Boston Ave.: Not brought up to grade. Needs access box and lid.

47 Brooklyn Ave.: Installed approx. 8 months ago. Needs proper access box and lid

462 Clifton Ave.: Cleanout is approx. 10' from P/L

52 Cleveland Ave.: Cleanout not to standard. Approx. 10' from P/L

64 Cleveland Ave.: Approx. 8' from P/L

28 Topeka Ave.: Cleanout not to standard. Approx. 1' from P/L
 70 Topeka Ave.: Cleanout needs proper access box and lid
 79 Topeka Ave.: Cleanout has "Storm" lid instead of "Sewer"
 114 Topeka Ave.: Cleanout not to standard. Approx. 10' from P/L
 121-3 Topeka Ave.: Cleanout needs proper access box and lid. Approx. 5' from P/L

1840 Forest Ave.: Cleanout is approx. 10' from P/L

315 Leland Ave.: Cleanout is on sidewalk between 315 Leland Ave (parking lot) and 1854 W. San Carlos

421 Leigh Ave.: Cleanout not to standard. Approx. 10' from P/L

2311 Olive Ave.: Cleanout not to standard. Approx. 10'-15' from P/L
 2469 Olive Ave.: Cleanout is approx. 10' from P/L. 1' from building

365 Raymond Ave.: Cleanout needs proper access box and lid
 407 Raymond Ave.: Cleanout has "Water" lid

313 Richmond Ave.: Cleanout is no to standard
 431 Richmond Ave.: Cleanout is no to standard. Approx. 10' from P/L

473 Rutland Ave.: Cleanout is approx. 8'-10' from P/L
 574 Rutland Ave.: Cleanout is approx. 1' from house. Not a P/L cleanout
